# **An Investigation of Enhanced Capability Thermal Barrier Coating Systems for Diesel Engine Components**

**Allison Gas Turbine Division  
General Motors Corporation  
Indianapolis, Indiana 46206-0420**

**(NASA-CR-174820) AN INVESTIGATION OF  
ENHANCED CAPABILITY THERMAL BARRIER COATING  
SYSTEMS FOR DIESEL ENGINE COMPONENTS Final  
Report (General Motors Corp.) 140 p  
HC A07/MF A01**

**August 1984**

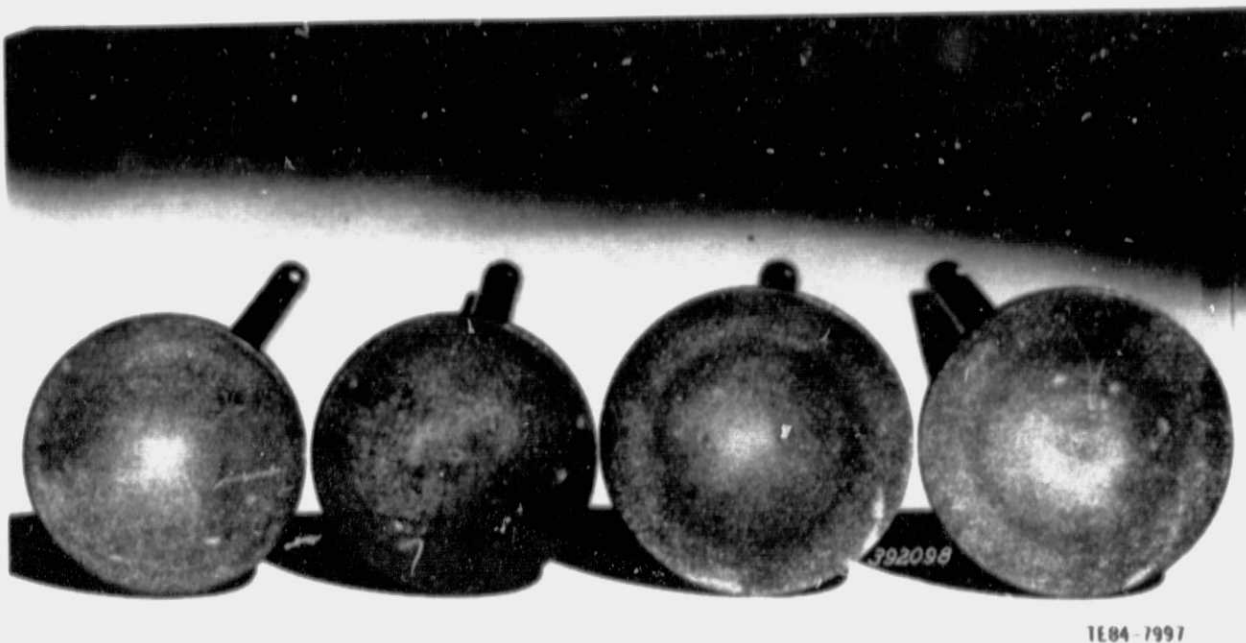
Figure 78. Coated valves after 4 hr of testing.
